Intel[®] Mobile Celeron[™] Processor Specification Update

Release Date: December 1999

Order Number: 244444-010

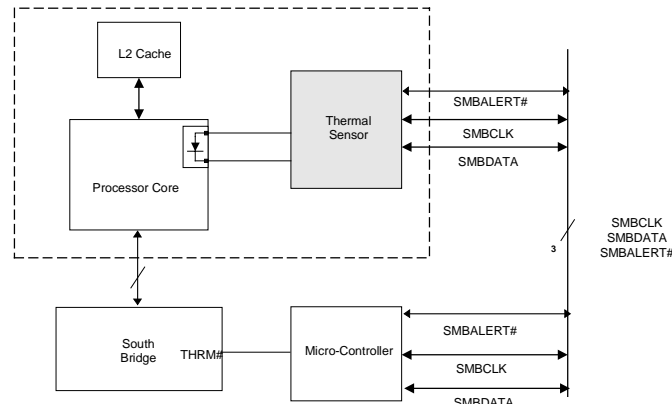
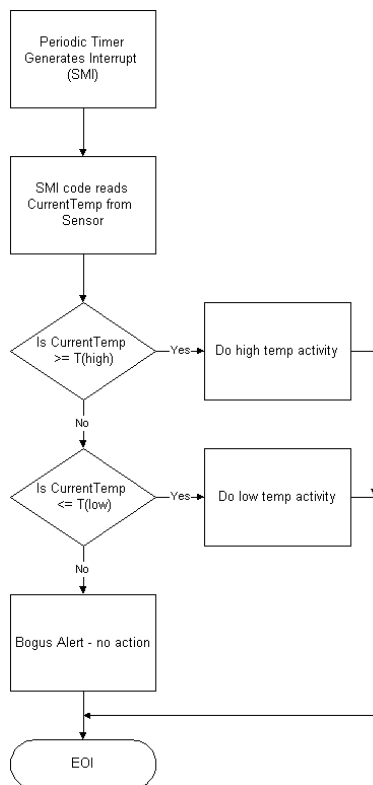
H29. Thermal Sensor May Assert SMBALERT# Incorrectly

Problem: The Intel Celeron Processor Mobile Module has a thermal sensor that monitors the processor core's temperature. Please note that desktop systems could have a similar thermal device. The thermal sensor asserts SMBALERT# if the processor temperature exceeds the temperature limits set in the Alarm Threshold Registers (T_{HIGH} , T_{LOW}). It also sets the corresponding Status Register bits to identify the cause of the interrupt. Figure 1 gives one example of the how the SMBALERT# signal could be used in a system.

Implication: There is no system impact from this erratum if temperature polling is used for processor thermal management. If the SMBALERT# interrupt is employed to manage processor thermal sensing, then servicing the false interrupt may result in premature system action depending on the software and hardware implementations used. The rate of the false interrupts is less than the auto-convert rate of the thermal sensor.

Workaround: Three different (mutually exclusive) workarounds are possible:

1. Before servicing an interrupt from the thermal sensor, read and compare the processor thermal reading with the threshold limits (T_{HIGH} or T_{LOW}). Figures 2 and 3 provide basic flowcharts for the implementation of this workaround in an interrupt driven system.
2. If the firmware implemented polls the Status Register only, then before taking any action, re-read the temperature register and do a comparison with the alarm threshold limits (T_{HIGH} or T_{LOW}) to determine if the value is actually still within the temperature window.
3. Use a temperature polling scheme to monitor the processor temperature.
